# Guide to Anhydrous Ammonia Safety

## Preventing Ammonia Accidents during Transportation and Application

### NH3 Release Scenarios Spring 2010

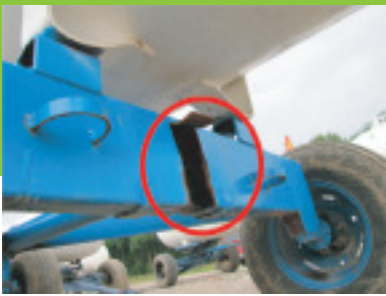
EXAMPLE 1

- Hitch failed due to wear. The nurse tank separated from the transport and rolled over into the ditch. [Brown County](#)
- **Correction:** Routine maintenance and inspection. Replace old worn parts with good working parts. Always attach the safety chains to the towing vehicle. (see [Example 1 & 2](#)) (see [example 16](#) for a poorly maintained hitch)

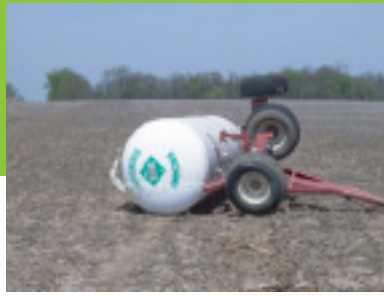
EXAMPLE 7

- **Correction:** Slow down. The tire rating on NH3 running gears is 25 mph. Although this is just a recommendation from the manufacturer, some running gears should not be pulled faster than 10 or 15 mph. SMV signs tell other motorists you are a slow moving vehicle. (see example 7) (see example 10 for proper way to transport NH3 nurse tanks)

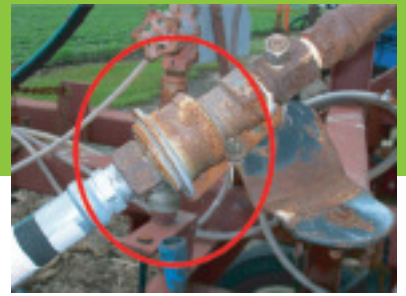
EXAMPLE 13

- **Correction:** Conduct routine inspection and maintenance of equipment. Replace all worn or outdated parts with new parts. In order for proper flow to activate the excess flow valve, the liquid withdraw valve must be fully open. The excess flow valve will not function properly by leaving a liquid withdraw valve partially closed. (see [examples 13, 14 and 18](#) to view poorly maintained equipment)

- **Correction:** Always attach the safety chains to the towing vehicle. Safety chains are designed as a secondary safety measure in the event the hitch pin breaks or fails to function properly. Routine maintenance and inspection of the quick coupler on the toolbar should be performed prior to any NH3 application. Replace worn or damaged parts with new working parts. Dispose of old parts. (See [examples 13 and 18](#) for improper working quick coupler) (see [example 5 & 9](#) or proper working quick coupler)

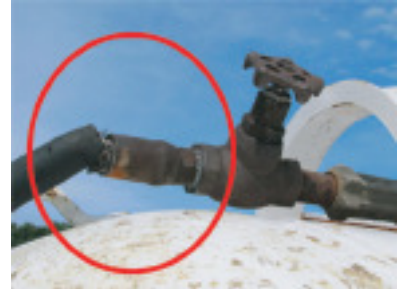
EXAMPLE 14

- Tractor was pulling a toolbar and nurse tank. The hose from the toolbar to the nurse tank worked loose. [Macoupin County](#)
- **Correction:** Routine daily inspection and maintenance should be performed on NH3 application equipment prior to use during the busy Spring and Fall NH3 application seasons. (see example 14)

- **Correction:** Close the liquid withdraw valve on the nurse tank(s) that is applying product to the toolbar. Bleed down the system, disconnect & secure the hoses from the toolbar to the nurse tank prior to navigating ditches, ravines or waterways. (see example 14)

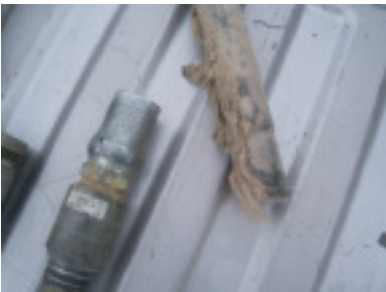
EXAMPLE 3

- **Correction:** Close the liquid withdraw valve on the nurse tank(s) that is supplying product to the toolbar, bleed down the system, disconnect & secure the hoses from the toolbar to the nurse tank(s) prior to navigating ditches, ravines or waterways. Always attach the safety chain to the towing vehicle. (see [Example 3](#)) (see [example 15](#) for improper use of safety chains)

- **Correction:** Close the liquid withdraw valve on the nurse tank(s) that is supplying product to the toolbar, bleed down the system, disconnect & secure the hoses from the toolbar to the nurse tank(s) prior to navigating ditches, ravines or waterways. (see [example 3](#) and [15](#))

- **Correction:** Make sure the transfer hose from the nurse tank to the toolbar is the appropriate length. Never use a 30 foot hose to make a 10 foot connection. (see example 3) (see example 15 for improper use of safety chains)

- Hole worn in hose supplying NH3 from the nurse tank to the toolbar. [Scott County](#)
- **Correction:** Routine daily inspection and maintenance of transfer hose from the toolbar to the NH3 nurse tank should always be conducted prior to starting application. Replace worn or defective parts with new parts. Dispose of old defective parts. (see example 3)

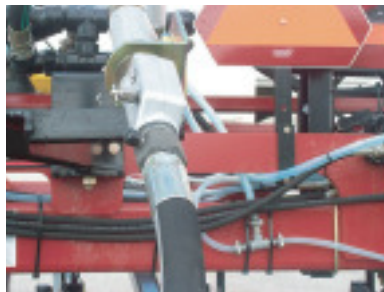
EXAMPLE 9

- **Correction:** Only one tank should be pulled behind a tractor and toolbar. In Illinois, it is illegal to exceed a combination of three vehicles. A tractor, toolbar and two nurse tanks pulled in tandem is considered four vehicles. Close the nurse tank liquid withdraw valve, disconnect & secure all transfer hoses prior to transporting a toolbar & tank upon a public roadway. Always securely attach safety chains to the towing vehicle prior to transport. (see [example 8](#) for proper nurse tank transport behind a toolbar) (See [examples 5 & 9](#) for proper working quick coupler)

- **Correction:** Always attach the safety chains to the towing vehicle. Safety chains are designed as a secondary safety measure in the event the hitch pin breaks or fails to function properly. Routine maintenance and inspection of the quick coupler on the toolbar should be performed prior to any NH3 application. Replace worn or damaged parts with new working parts. Dispose of old parts. (See examples 13 and 18 for poorly maintained quick coupler) (see examples 5 & 9 for properly maintained and working quick coupler)

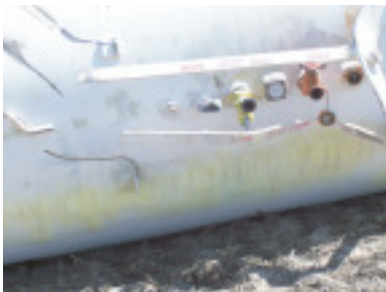
EXAMPLE 4

- **Correction:** Shut the liquid withdraw valve off, bleed down the system and unhook the hose from the toolbar to the liquid withdraw valve on the nurse tank prior to entering the field of application. When entering the field of application from a public roadway, the nurse tank liquid withdraw valve shall be closed & all transfer hoses disconnected and secured. (see example 4)

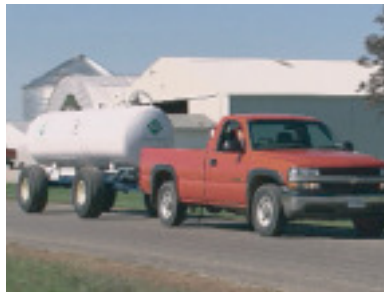
EXAMPLE 10

- **Correction:** Slow down. The tire rating on NH3 running gears is 25 mph. Although this is just a recommendation from the manufacturer, some running gears should not be pulled faster than 10 or 15 mph. SMV sign tells other motorists you are a slow moving vehicle. (See [example 10](#) for proper way to tow a NH3 nurse tank) (See [example 6](#) to view poor equipment maintenance)

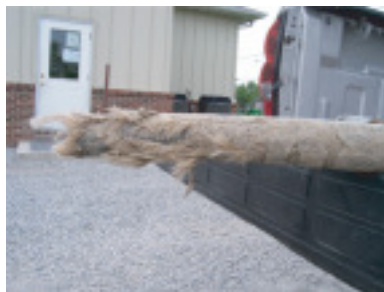
EXAMPLE 11

- Hose connecting nurse tank to toolbar burst due to rubbing on toolbar. [Cumberland County](#)
- **Correction:** Routine daily inspection and maintenance of transfer hose from the toolbar to the NH3 nurse tank should always be conducted prior to starting application. Replace worn or defective parts with new parts. Dispose of old defective parts. Always secure the transfer hose prior to transporting equipment. (see example 11)

- **Correction:** Close the liquid withdraw valve on the nurse tank that is applying product to the toolbar. Bleed down the system, disconnect & secure the hoses from the toolbar to the nurse tank prior to entering the field of application. The nurse tank(s) liquid withdraw valve shall be closed & all transfer hoses disconnected & secured until application begins. Always make sure to use the proper length hose. A 30 foot hose should not be used to make a 15 foot connection. (see example 3 and 11)

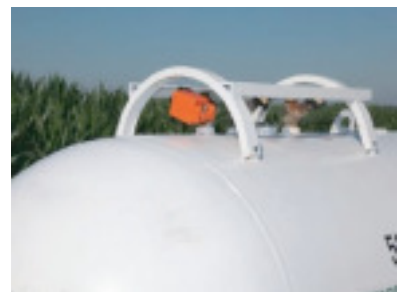
EXAMPLE 17

- 580 gallon anhydrous ammonia release occurred due to attempted theft. [Vermilion County](#)
- **Correction:** Return nurse tanks to the ag retail facility when they are no longer in use. Place locking devices or other means of security on nurse tank(s) when they are not in use. (see [example 12](#)) (see [example 17](#) for proper use of locking devices)
