Guide to Anhydrous Ammonia Safety

Preventing Ammonia Accidents during Transportation and Application

NH3 Release Scenarios Spring 2010

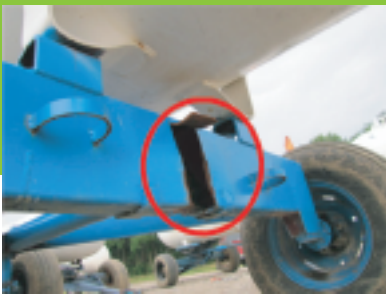
EXAMPLE 1

- Hitch failed due to wear. The nurse tank separated from the transport and rolled over into the ditch. [Brown County](#)
- **Correction:** Routine maintenance and inspection. Replace old worn parts with good working parts. Always attach the safety chains to the towing vehicle. (see [Example 1 & 2](#)) (see [example 16](#) for a poorly maintained hitch)

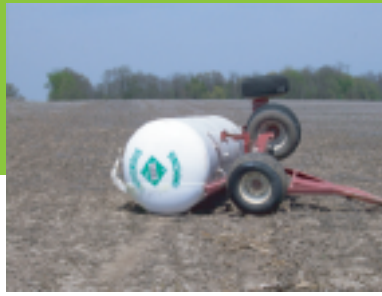
EXAMPLE 7

- Truck transporting a pair of NH3 nurse tanks. Back nurse tank turned over and valve partially opened as a result of the accident. [Hancock County](#)

- **Correction:** Slow down. The tire rating on NH3 running gears is 25 mph. Although this is just a recommendation from the manufacturer, some running gears should not be pulled faster than 10 or 15 mph. SMV signs tell other motorists you are a slow moving vehicle. (see example 7) (see example 10 for proper way to transport NH3 nurse tanks)

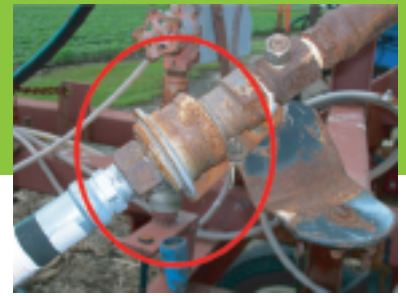
EXAMPLE 13

- **Correction:** Conduct routine inspection and maintenance of equipment. Replace all worn or outdated parts with new parts. In order for proper flow to activate the excess flow valve, the liquid withdraw valve must be fully open. The excess flow valve will not function properly by leaving a liquid withdraw valve partially closed. (see [examples 13, 14 and 18](#) to view poorly maintained equipment)

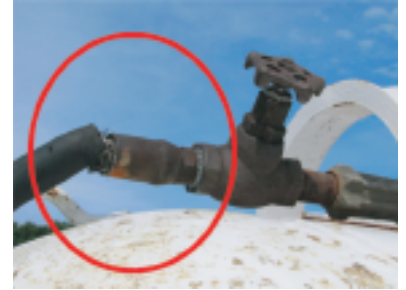
EXAMPLE 14

- Tractor was pulling a toolbar and nurse tank. The hose from the toolbar to the nurse tank worked loose. [Macoupin County](#)
- **Correction:** Routine daily inspection and maintenance should be performed on NH3 application equipment prior to use during the busy Spring and Fall NH3 application seasons. (see example 14)

- **Correction:** Close the liquid withdraw valve on the nurse tank(s) that is applying product to the toolbar. Bleed down the system, disconnect & secure the hoses from the toolbar to the nurse tank prior to navigating ditches, ravines or waterways. (see example 14)

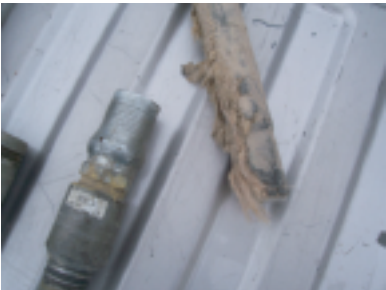
EXAMPLE 3

- When turning while crossing a waterway with tractor, toolbar and nurse tank, the hose pulled the liquid withdraw valve off the nurse tank. [Greene County](#)

- **Correction:** Close the liquid withdraw valve on the nurse tank(s) that is supplying product to the toolbar, bleed down the system, disconnect & secure the hoses from the toolbar to the nurse tank(s) prior to navigating ditches, ravines or waterways. Always attach the safety chain to the towing vehicle. (see [Example 3](#)) (see [example 15](#) for improper use of safety chains)

- Going through a ravine dividing two fields, the applicator hose was not long enough to navigate through the crossing. This caused the liquid withdraw valve to break off. [Calhoun County](#)

- **Correction:** Close the liquid withdraw valve on the nurse tank(s) that is supplying product to the toolbar, bleed down the system, disconnect & secure the hoses from the toolbar to the nurse tank(s) prior to navigating ditches, ravines or waterways. (see [example 3](#) and [15](#))

- **Correction:** Make sure the transfer hose from the nurse tank to the toolbar is the appropriate length. Never use a 30 foot hose to make a 10 foot connection. (see example 3) (see example 15 for improper use of safety chains)

- Hole worn in hose supplying NH3 from the nurse tank to the toolbar. [Scott County](#)
- **Correction:** Routine daily inspection and maintenance of transfer hose from the toolbar to the NH3 nurse tank should always be conducted prior to starting application. Replace worn or defective parts with new parts. Dispose of old defective parts. (see example 3)

- **Correction:** Close the liquid withdraw valve on the nurse tank that is applying product to the toolbar. Bleed down the system, disconnect & secure the hoses from the toolbar to the nurse tank prior to entering the field of application. The nurse tank(s) liquid withdraw valve shall be closed & all transfer hoses disconnected & secured until application begins. Always make sure to use the proper length hose. A 30 foot hose should not be used to make a 15 foot connection. (see example 3 and 11)

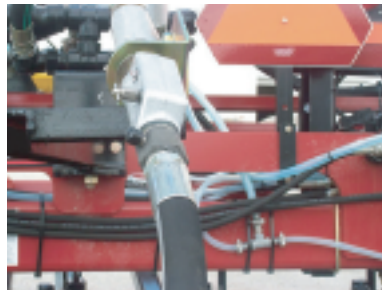
EXAMPLE 9

- **Correction:** Only one tank should be pulled behind a tractor and toolbar. In Illinois, it is illegal to exceed a combination of three vehicles. A tractor, toolbar and two nurse tanks pulled in tandem is considered four vehicles. Close the nurse tank liquid withdraw valve, disconnect & secure all transfer hoses prior to transporting a toolbar & tank upon a public roadway. Always securely attach safety chains to the towing vehicle prior to transport. (see [example 8](#) for proper nurse tank transport behind a toolbar) (See [examples 5 & 9](#) for proper working quick coupler)

- **Correction:** Always attach the safety chains to the towing vehicle. Safety chains are designed as a secondary safety measure in the event the hitch pin breaks or fails to function properly. Routine maintenance and inspection of the quick coupler on the toolbar should be performed prior to any NH3 application. Replace worn or damaged parts with new working parts. Dispose of old parts. (See [examples 13 and 18](#) for improper working quick coupler) (see [example 5 & 9](#) or proper working quick coupler)

- **Correction:** Always attach the safety chains to the towing vehicle. Safety chains are designed as a secondary safety measure in the event the hitch pin breaks or fails to function properly. Routine maintenance and inspection of the quick coupler on the toolbar should be performed prior to any NH3 application. Replace worn or damaged parts with new working parts. Dispose of old parts. (See examples 13 and 18 for poorly maintained quick coupler) (see examples 5 & 9 for properly maintained and working quick coupler)

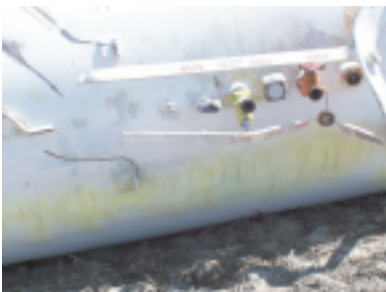
EXAMPLE 4

- While entering a field with tractor, toolbar and nurse tank, the tank rolled over. The liquid hose broke off at the liquid withdraw valve. [Jackson County](#)

- **Correction:** Shut the liquid withdraw valve off, bleed down the system and unhook the hose from the toolbar to the liquid withdraw valve on the nurse tank prior to entering the field of application. When entering the field of application from a public roadway, the nurse tank liquid withdraw valve shall be closed & all transfer hoses disconnected and secured. (see example 4)

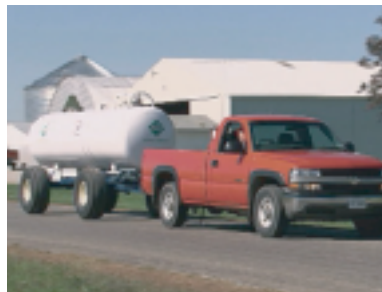
EXAMPLE 10

- **Correction:** Slow down. The tire rating on NH3 running gears is 25 mph. Although this is just a recommendation from the manufacturer, some running gears should not be pulled faster than 10 or 15 mph. SMV sign tells other motorists you are a slow moving vehicle. (See [example 10](#) for proper way to tow a NH3 nurse tank) (See [example 6](#) to view poor equipment maintenance)

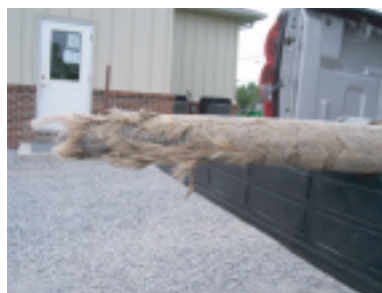
EXAMPLE 11

- Hose connecting nurse tank to toolbar burst due to rubbing on toolbar. [Cumberland County](#)
- **Correction:** Routine daily inspection and maintenance of transfer hose from the toolbar to the NH3 nurse tank should always be conducted prior to starting application. Replace worn or defective parts with new parts. Dispose of old defective parts. Always secure the transfer hose prior to transporting equipment. (see example 11)

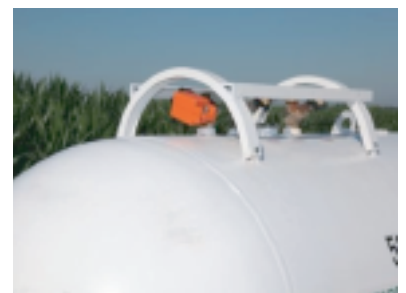
EXAMPLE 17

- 580 gallon anhydrous ammonia release occurred due to attempted theft. [Vermilion County](#)
- **Correction:** Return nurse tanks to the ag retail facility when they are no longer in use. Place locking devices or other means of security on nurse tank(s) when they are not in use. (see [example 12](#)) (see [example 17](#) for proper use of locking devices)

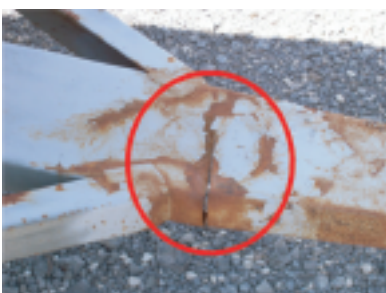
EXAMPLE 6

- While truck was pulling a nurse tank, the tank began to whip back and forth. The driver slowed down but the tank whipped harder and rolled over snapping the end of the tongue on the wagon causing the liquid withdraw valve and vapor valves to break off. [McDonough County](#)
